Technical Service Bulletin

SUBJECT: Oil Filter Cap
2014 – 2018 Chrysler / Jeep vehicles
equipped with Pentastar V6 3.6L engine

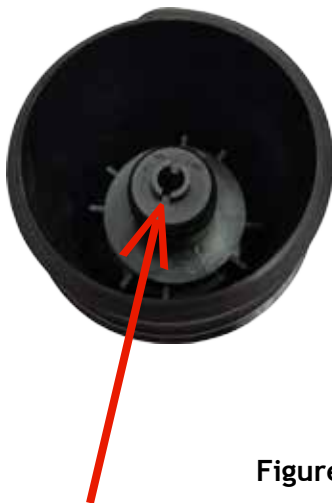
Figure 1

The oil by-pass valve is located in the oil filter cap (see figure 1). If the locking tabs holding the bypass-valve in place break, or disengage from the by-pass valve spring, the valve is free to move down the center tube of the oil filter and could become lodged in the tube (see figure 2). This can create an oil flow blockage and could cause severe engine damage.

Cap with valve
in place

This is not a defective oil filter. It is a malfunction or breakage of the oil filter cap. Carefully inspect the cap before installing a new oil filter. If the by-pass valve is missing, broken or damaged, replace the cap.

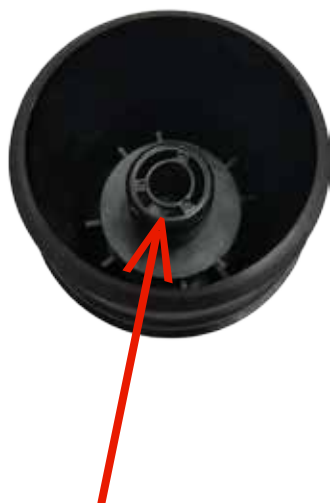
Cap with valve missing

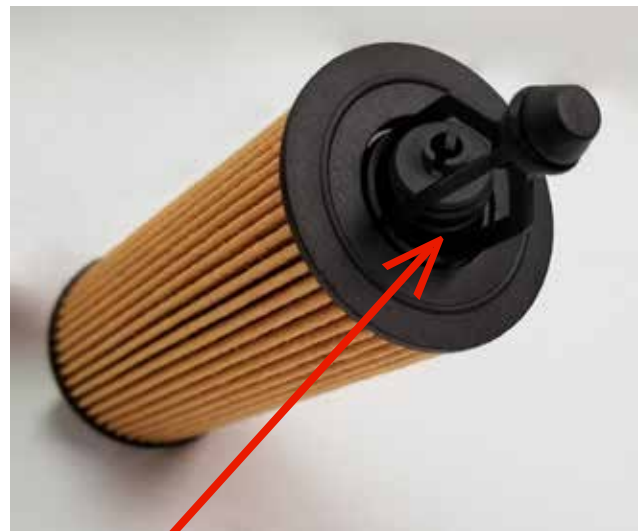
Figure 2

Oil by-pass valve wedged in oil filter

The **OE** replacement cap from Complete Lube Supply is **6296CAP** (6819 1350A - 001).
