Technical Service Bulletin

SUBJECT: Oil Filter Cap
(2014 – 2021) Chrysler / Jeep vehicles
equipped with Pentastar V6 3.6L engine

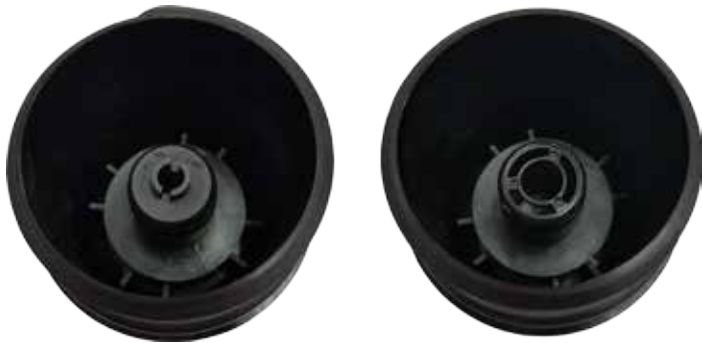
Figure 1

The oil by-pass valve is located in the oil filter cap (see figure 1). If the locking tabs holding the bypass-valve in place break, or disengage from the by-pass valve spring, the valve is free to move down the center tube of the oil filter and could become lodged in the tube (see figure 2). This can create an oil flow blockage and could cause severe engine damage.

Cap with valve
in place

Cap with valve missing

This is not a defective oil filter. It is a malfunction or breakage of the oil filter cap. Carefully inspect the cap before installing a new oil filter. If the by-pass valve is missing, broken or damaged, replace the cap.

The **OE** replacement cap from Complete Lube Supply is **6296CAP** (6819 1350A - 001).

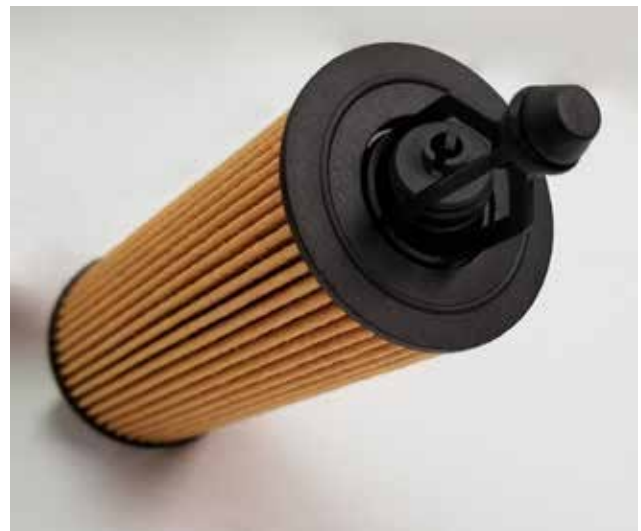
Figure 2

Oil by-pass valve wedged in oil filter
